**Tank Cleaning Chemical
PDS-660 Cleaner Case Study
March 2018**

Sterrex Industries PDS-660 CRUDE OIL TANK CHEMICALLY CLEANED RESULTS

CONVENTIONAL/MECHANICAL CRUDE OIL TANK CLEANING RESULTS

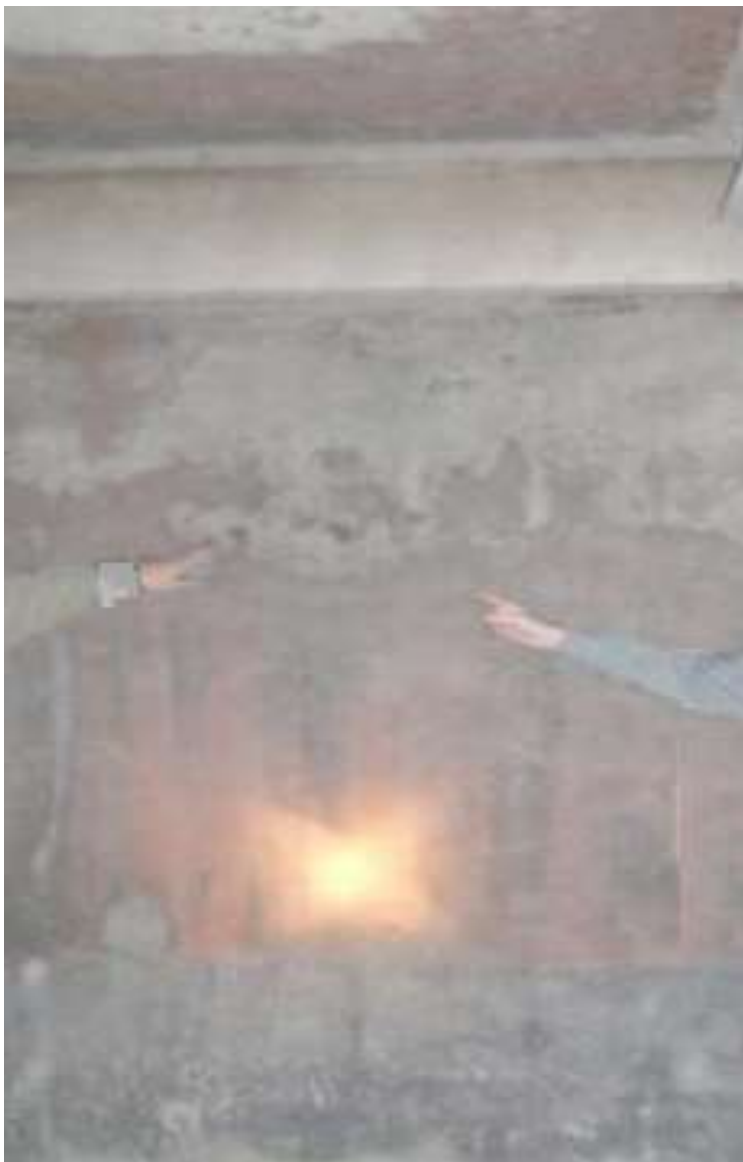
**Photograph 3 of 6
PDS-660 CHEMICAL CLEANING
RESULTS**

The men in the picture are pointing to scale remaining on the tank wall, prior to sand blasting. Appearance indicates it is silicate (sand) and iron sulfide residue. The scale fell off to the touch and could easily be removed with a handheld scraper.

Bright spot in this picture is camera flash reflection and is an indicator of the PDS-660 cleaner effectiveness. Subsequent photographs of an adjacent tank cleaned in the mechanical or conventional methods will highlight the success achieved using the chemical cleaning option using the PDS-660 cleaner.

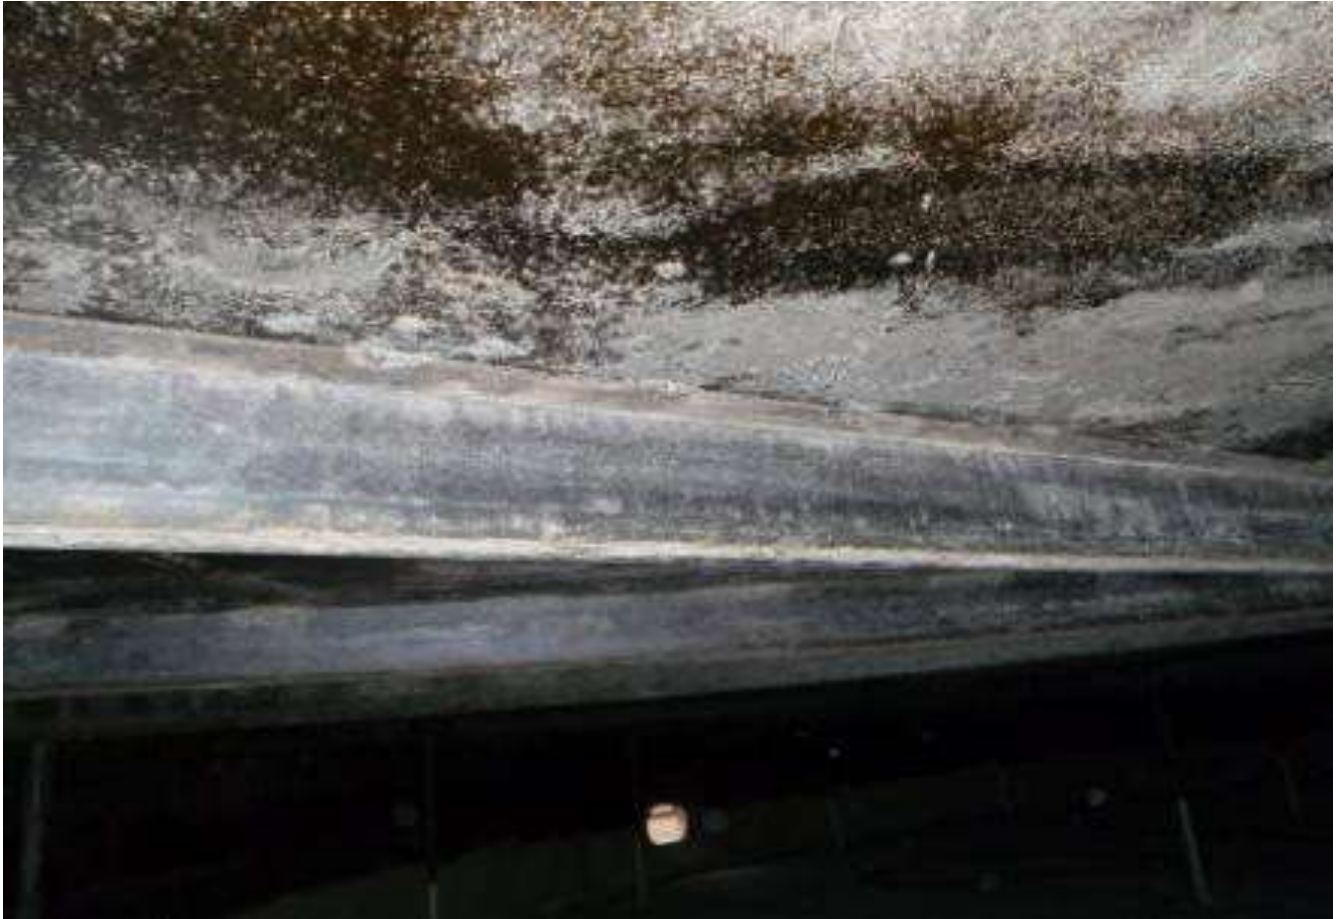
Photograph 1 of 6
CONVENTIONAL MECHANICAL CLEANING

The photo above and the next photos below are of a tank that was being cleaned conventionally or mechanically, NOT using the proprietary chemical from Sterrex Industries called PDS-660 cleaner. Bright spots in the bottom center of photograph is light entering through open access hatch. Radial roof ribs and roof underside appear in the upper foreground.
