Sterrex Industries

**Tank Cleaning Chemical
PDS-660 Cleaner Case Study
March 2018**

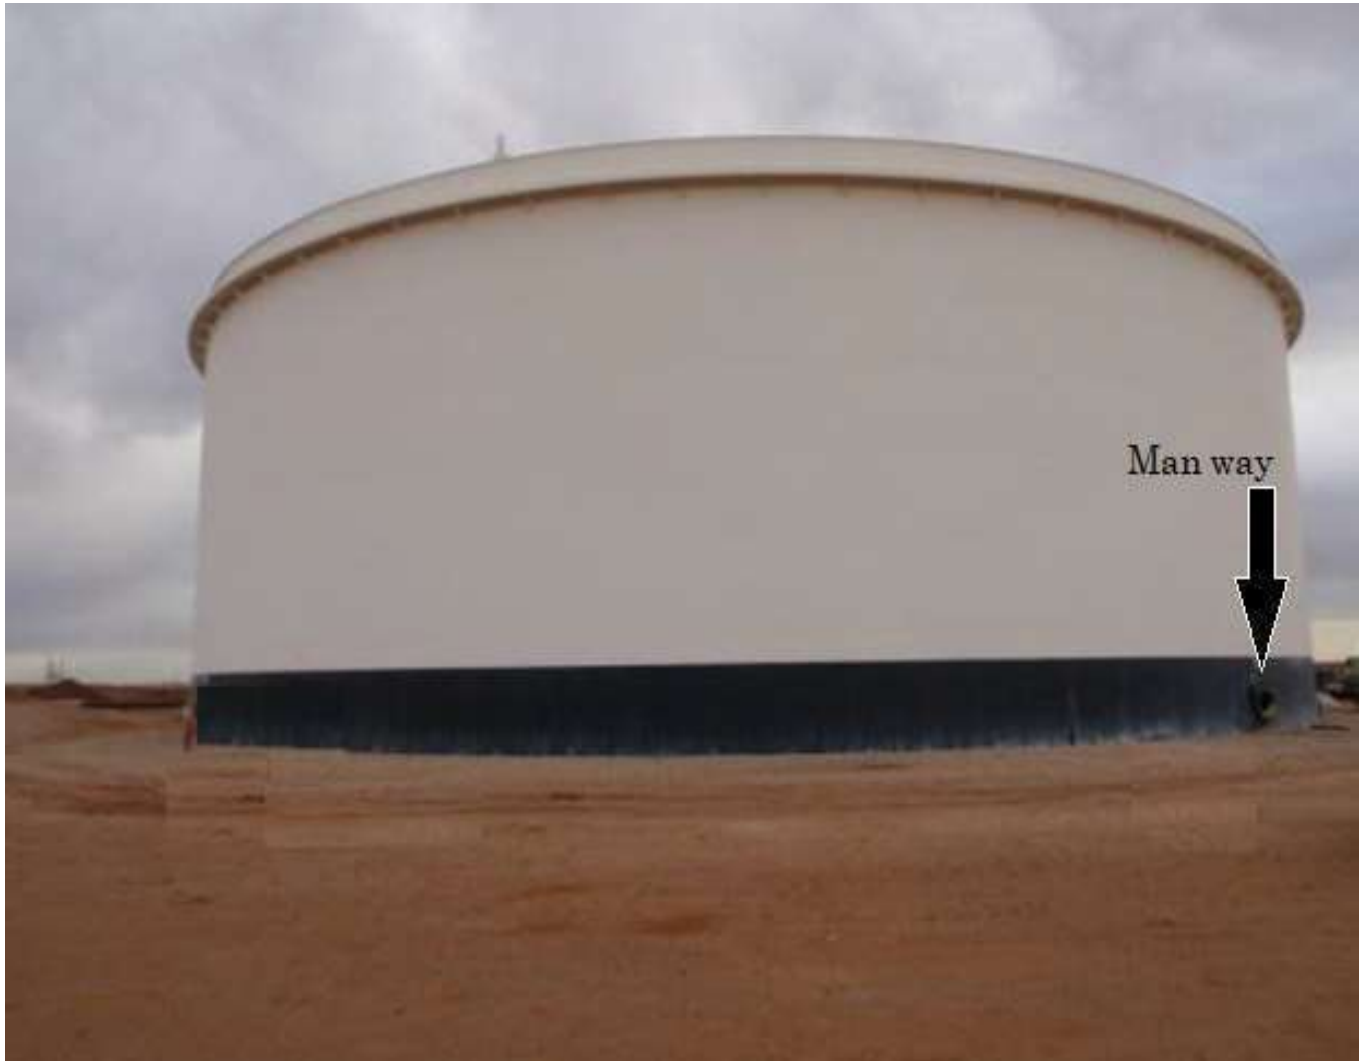
Photograph 1 of 6
PDS-660 CHEMICAL
CLEANING RESULTS

This tank was chemically cleaned using the Sterrex Industries PDS-660 cleaner.

This 100,000/bbl. crude oil storage tank was being cleaned so it could be readied for an API 653 inspection. Arrow indicates open hatch, through which personnel gained access to the empty, nearly clean tank.

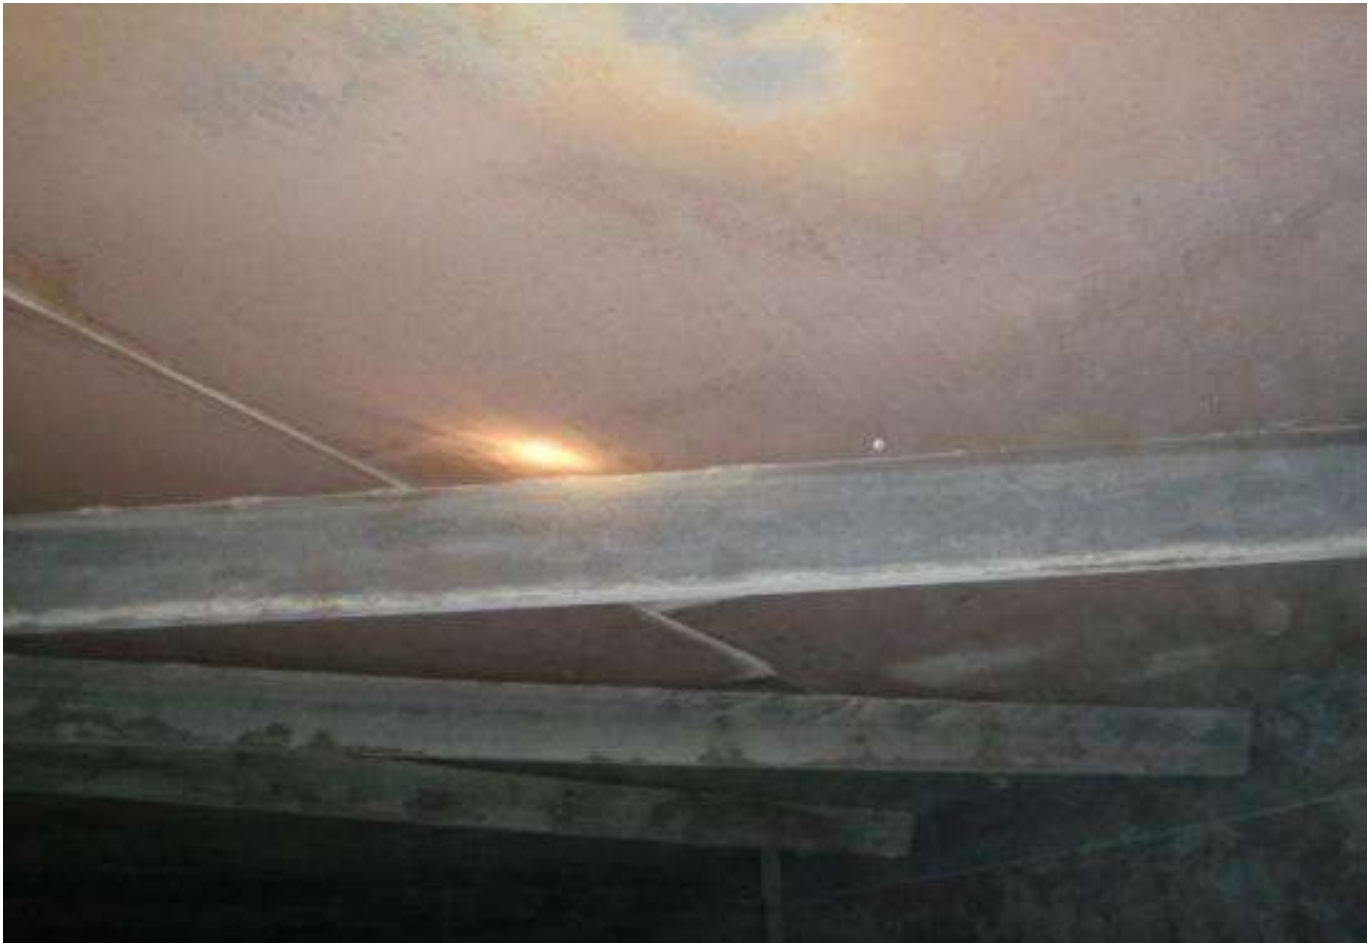
**Photograph 4 of 6
PDS-660 CHEMICAL CLEANING
RESULTS**

View of floating roof from inside of tank, showing radial ribs. Bright spot in this picture is camera flash reflection. We were told by tank company personnel that this roof had not been cleaned in any way other than by application of Sterrex Industries PDS-660 chemical.

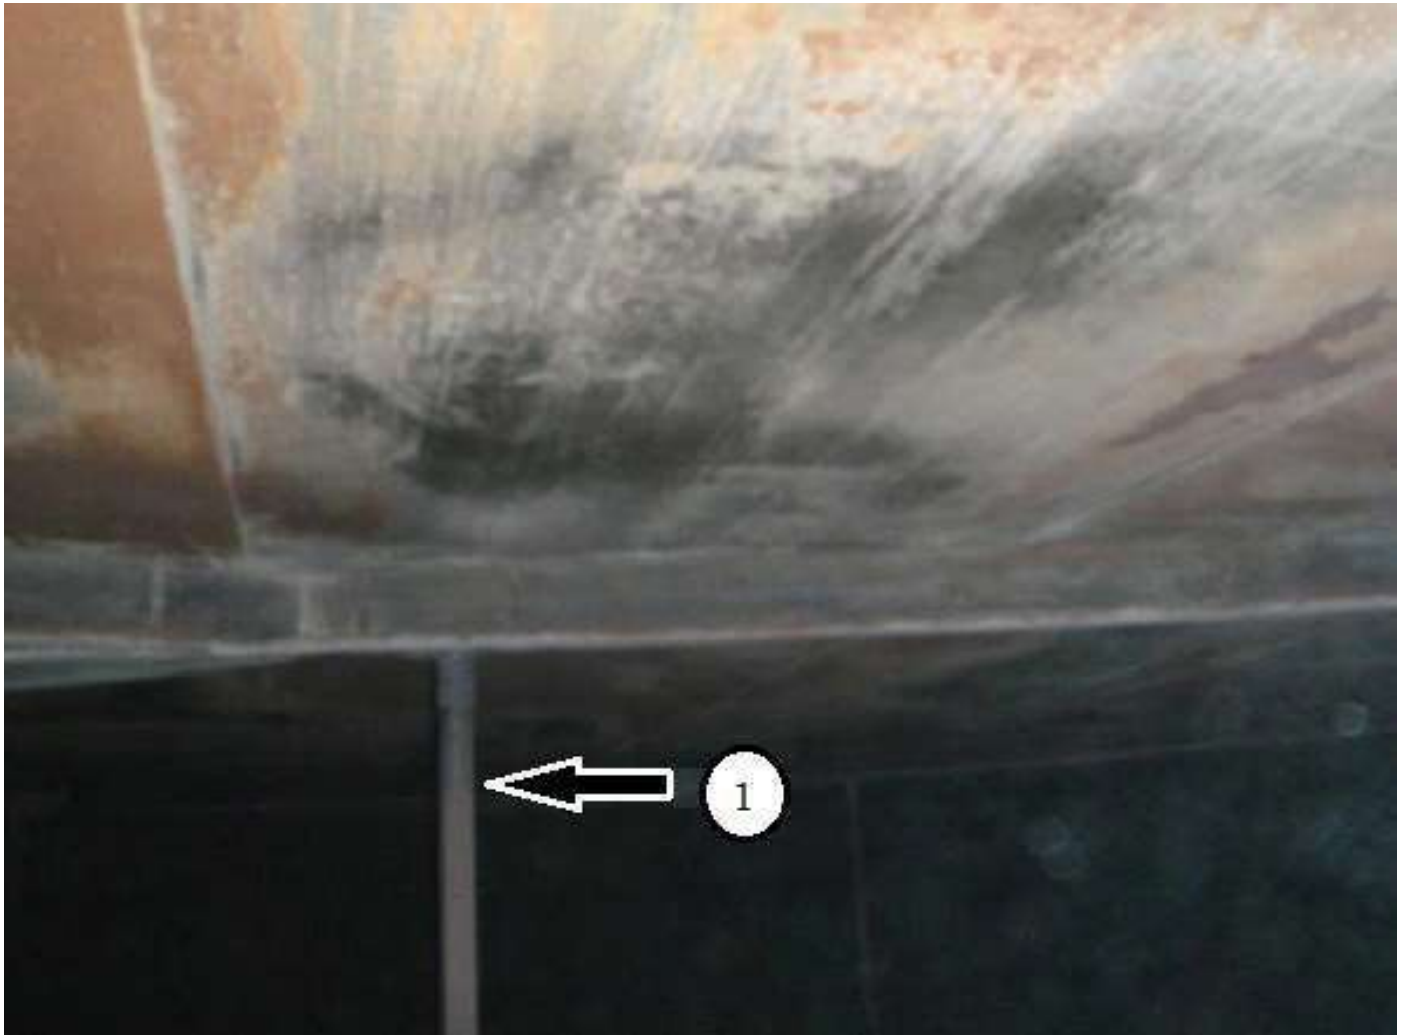
**Photograph 5 of 6
PDS-660 CHEMICAL CLEANING
RESULTS**

View of the inside of the floating tank roof, closer to the center of the tank.

1. Arrow 1 indicates one of the roof legs stops for the floating tank roof.

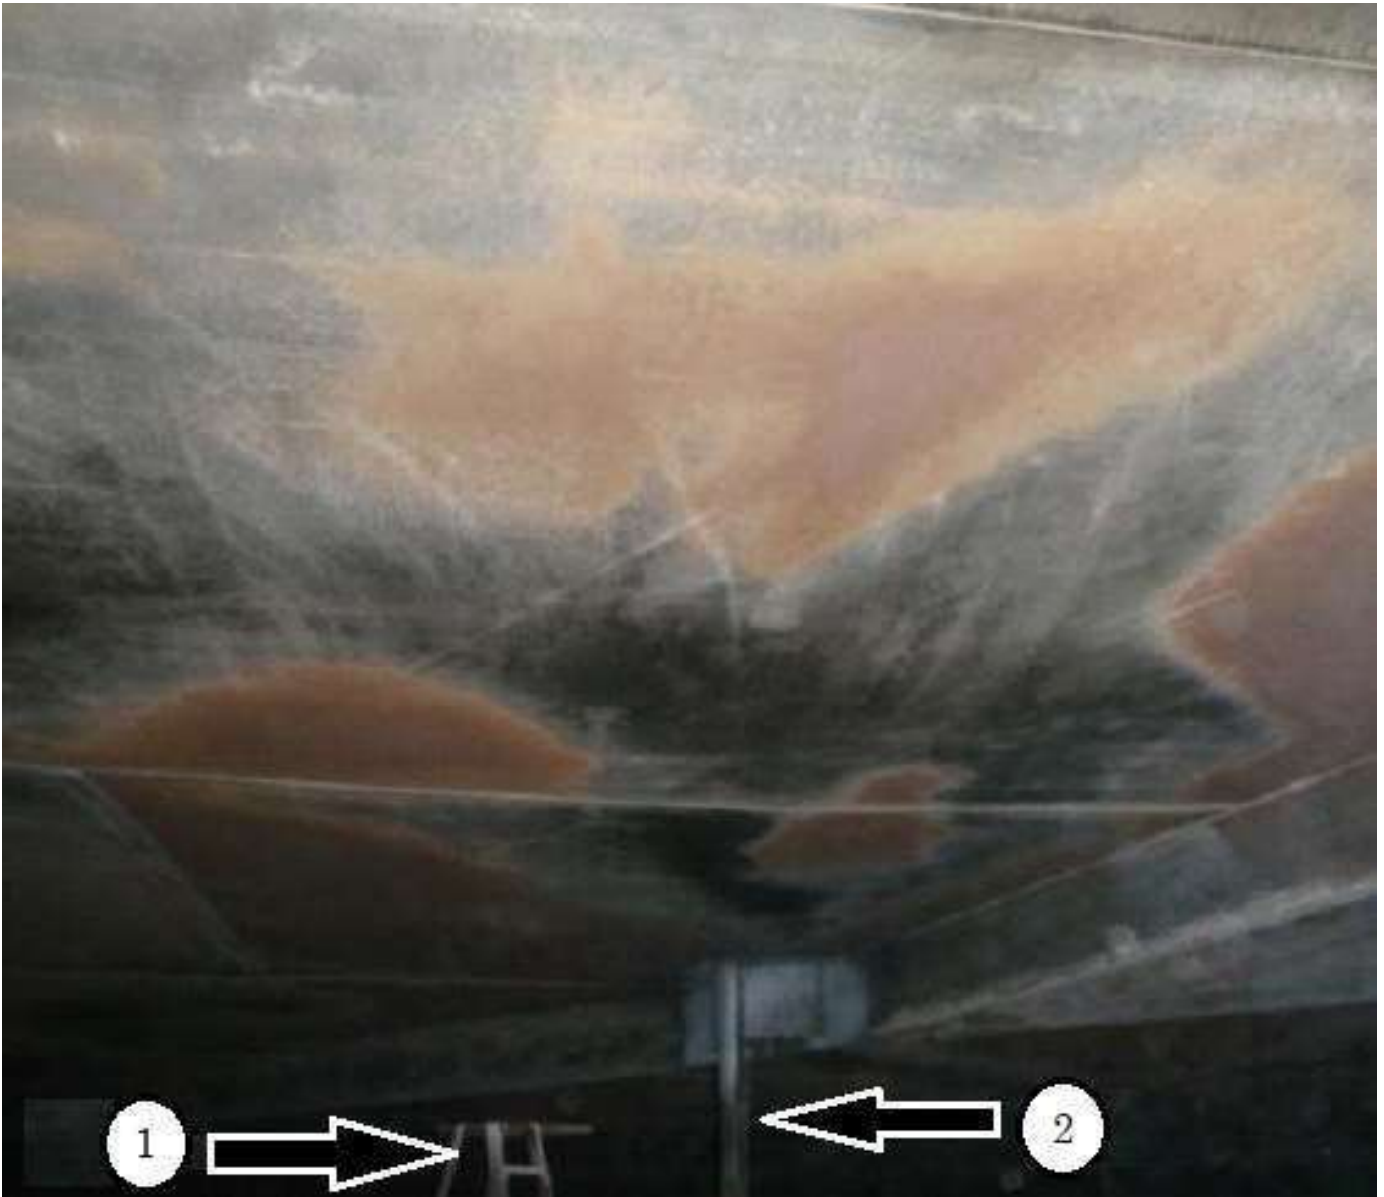
**Photograph 6 of 6
PDS-660 CHEMICAL CLEANING
RESULTS**

Photograph of floating tank roof from inside crude oil storage tank.

- 1. Arrow 1 indicates step ladder that is extending through an access hatch or man way through the floating roof.**
- 2. Arrow 2 indicates one of the roof leg stops for the floating tank roof.**

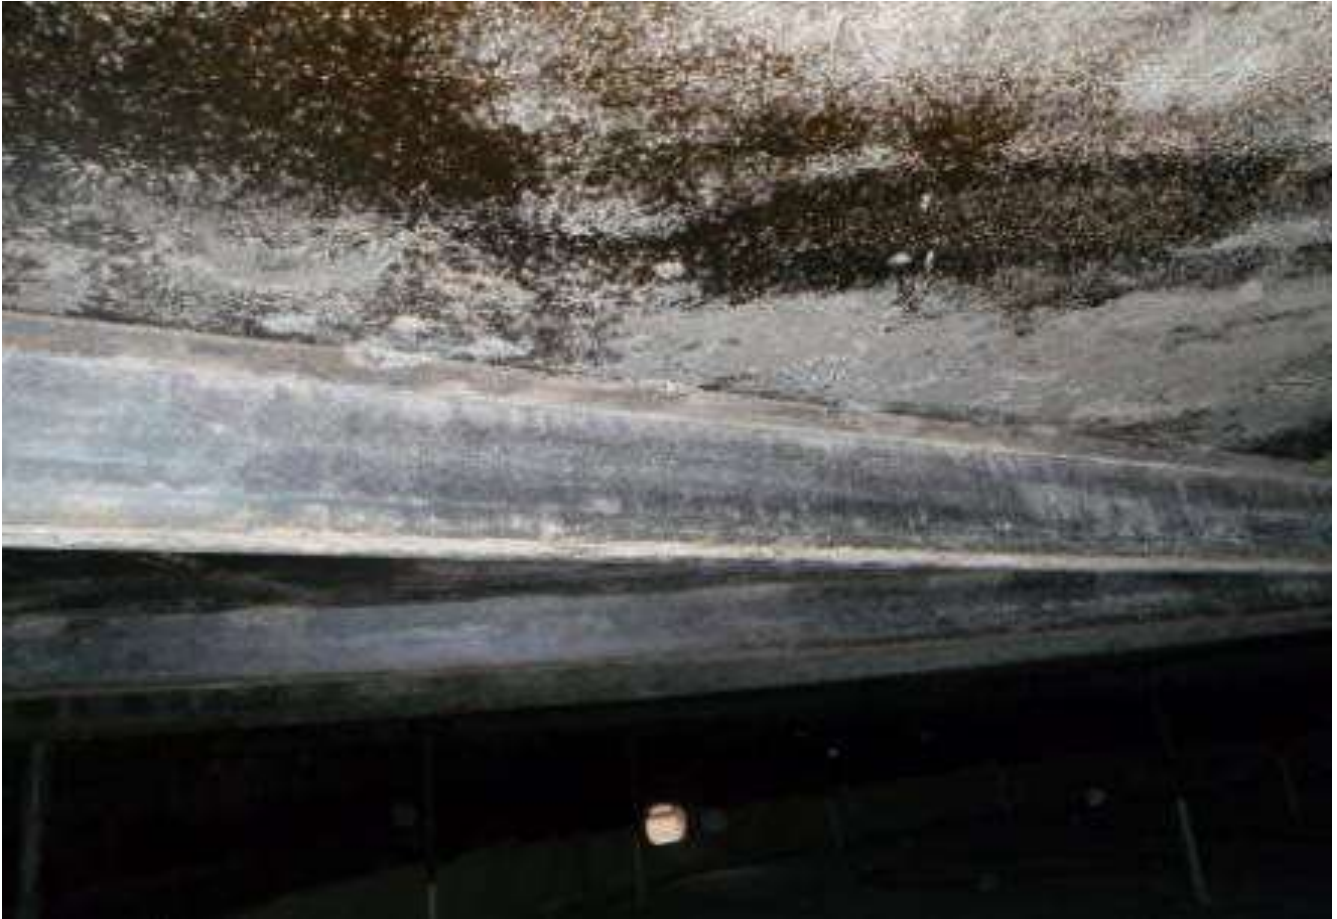
Photograph 1 of 6
CONVENTIONAL MECHANICAL CLEANING

The photo above and the next photos below are of a tank that was being cleaned conventionally or mechanically, NOT using the proprietary chemical from Sterrex Industries called PDS-660 cleaner. Bright spots in the bottom center of photograph is light entering through open access hatch. Radial roof ribs and roof underside appear in the upper foreground.

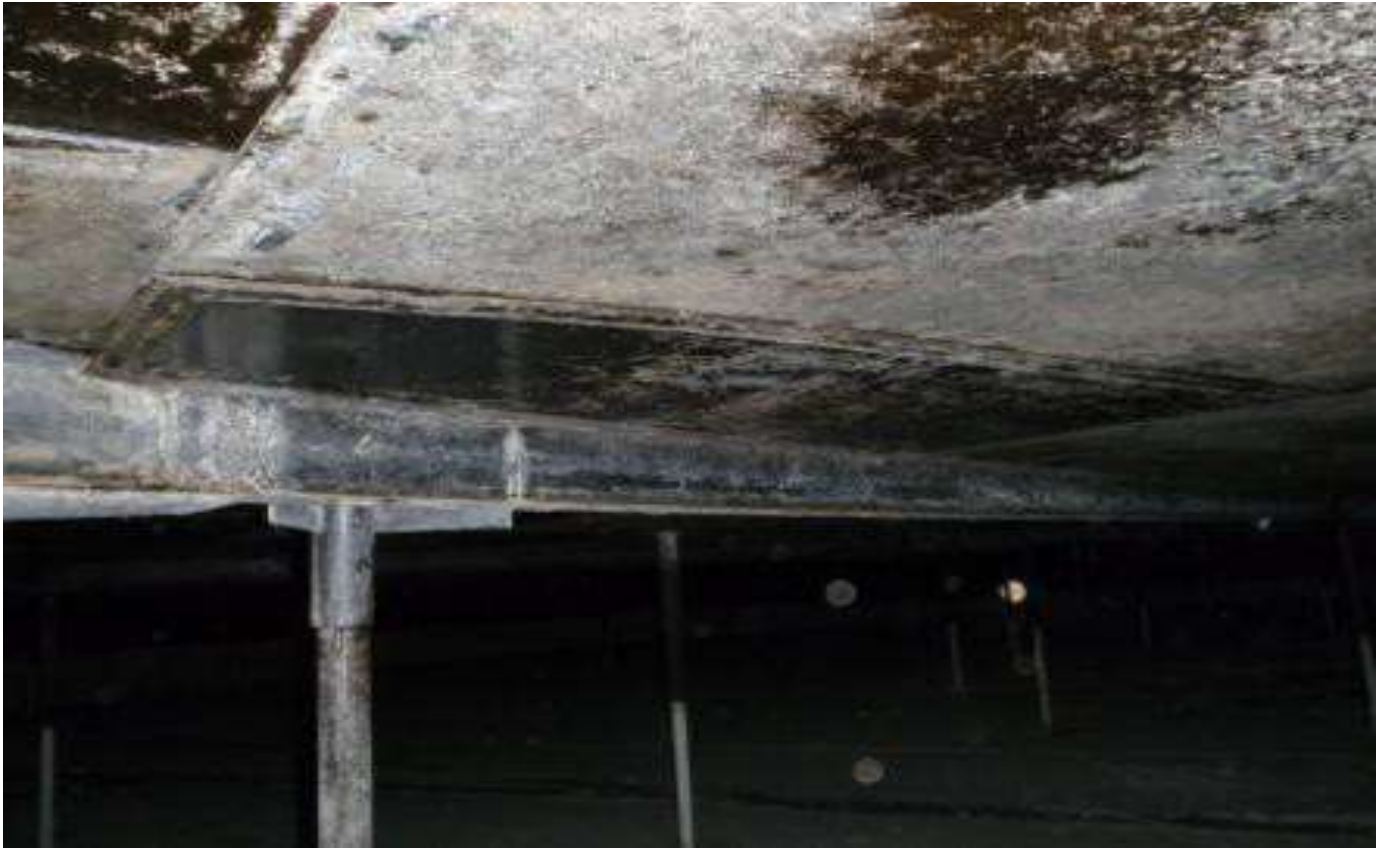
**Photograph 2 of 6
CONVENTIONAL MECHANICAL CLEANING**

Underside of the floating roof; white areas are hard paraffin deposits; darker splotches are remaining residual sludge.

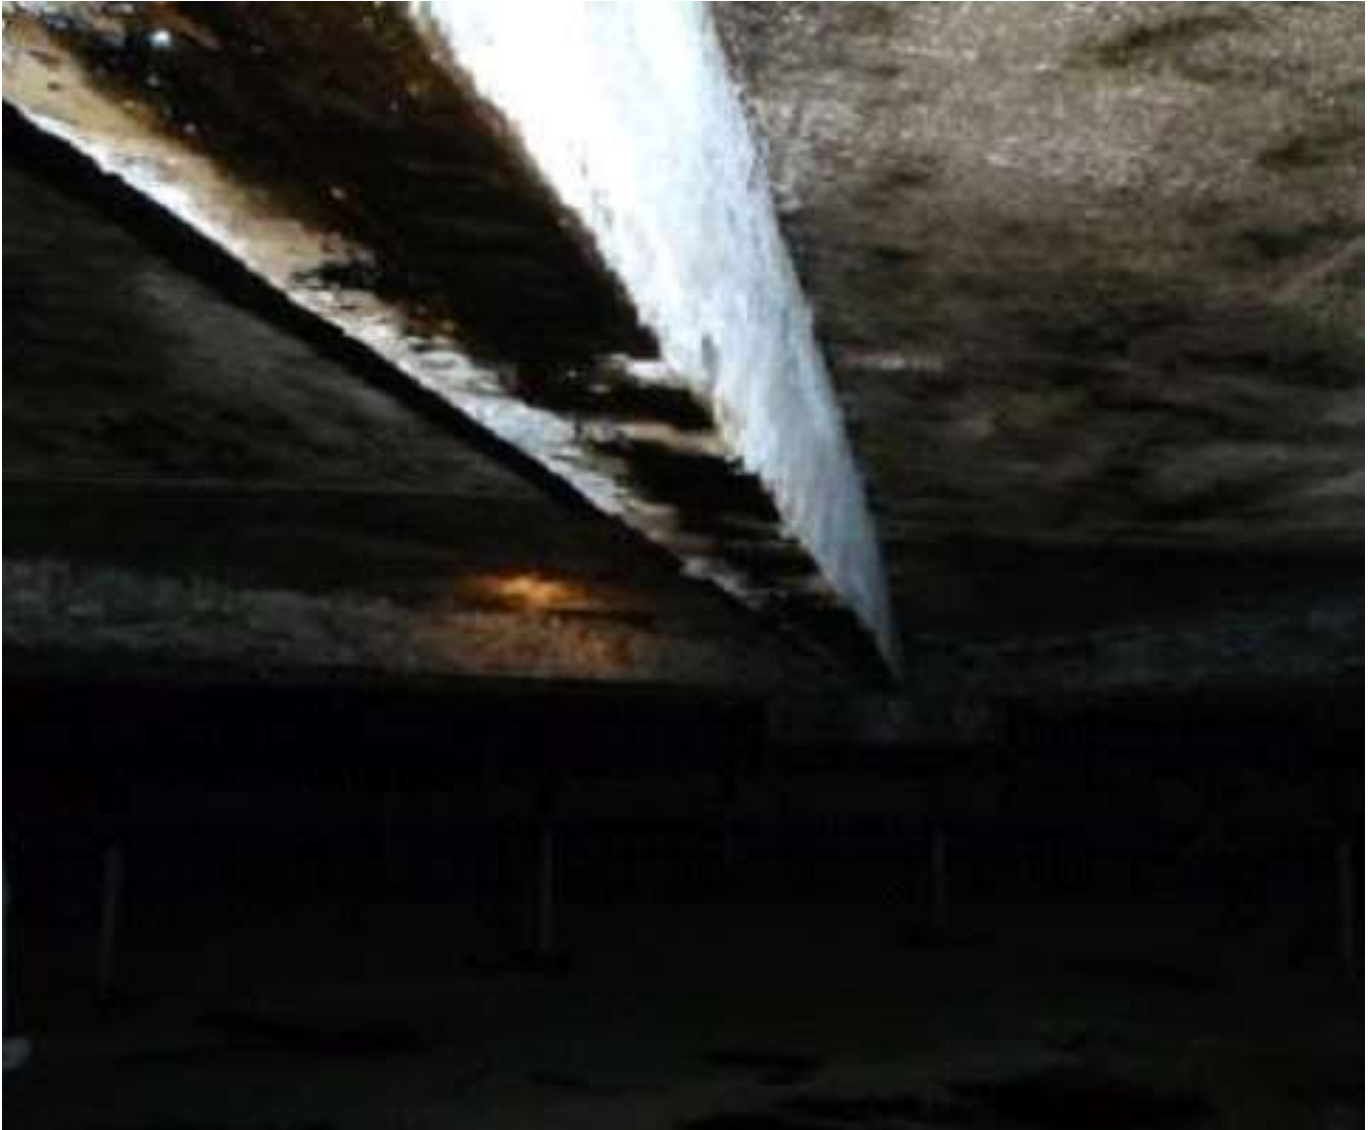
Photograph 4 of 6
CONVENTIONAL MECHANICAL CLEANING

One roof rib from side looking towards center. Note: Paraffin deposits on roof rib extending from foreground to center circular piece.

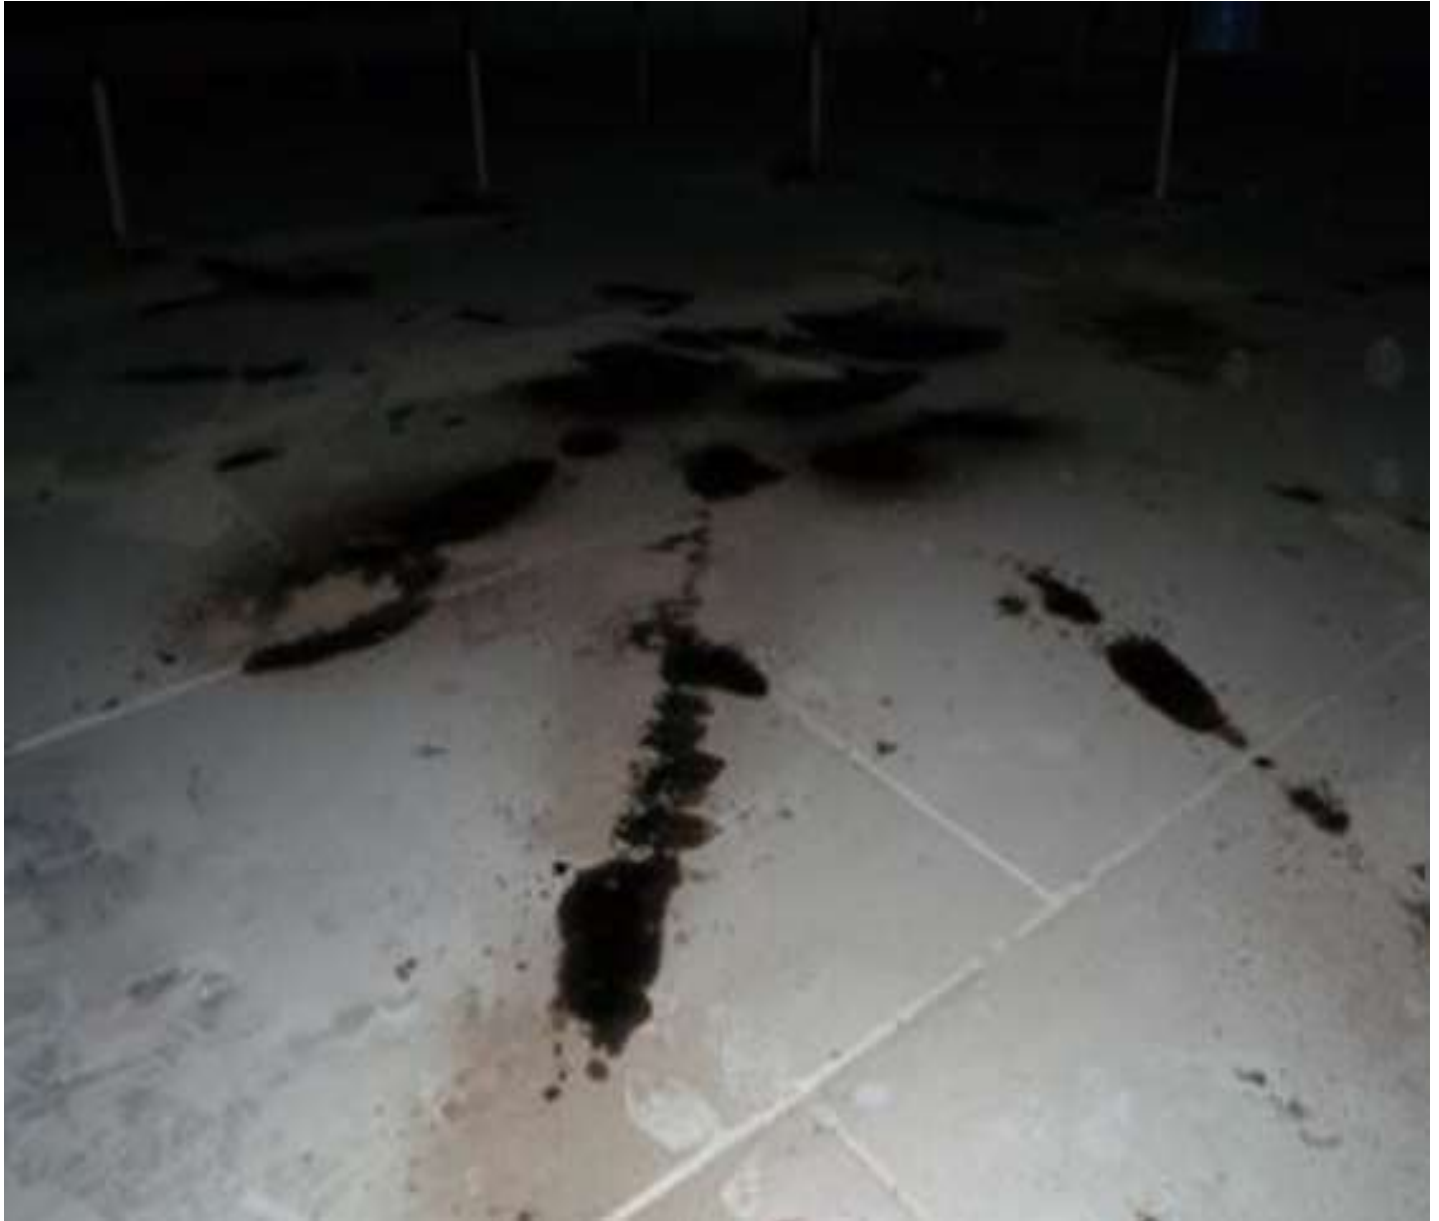
Photograph 5 of 6
CONVENTIONAL MECHANICAL CLEANING

Sludge remaining on tank floor. Floor is whitish gray in person and cleaning is still in process to finish the job.

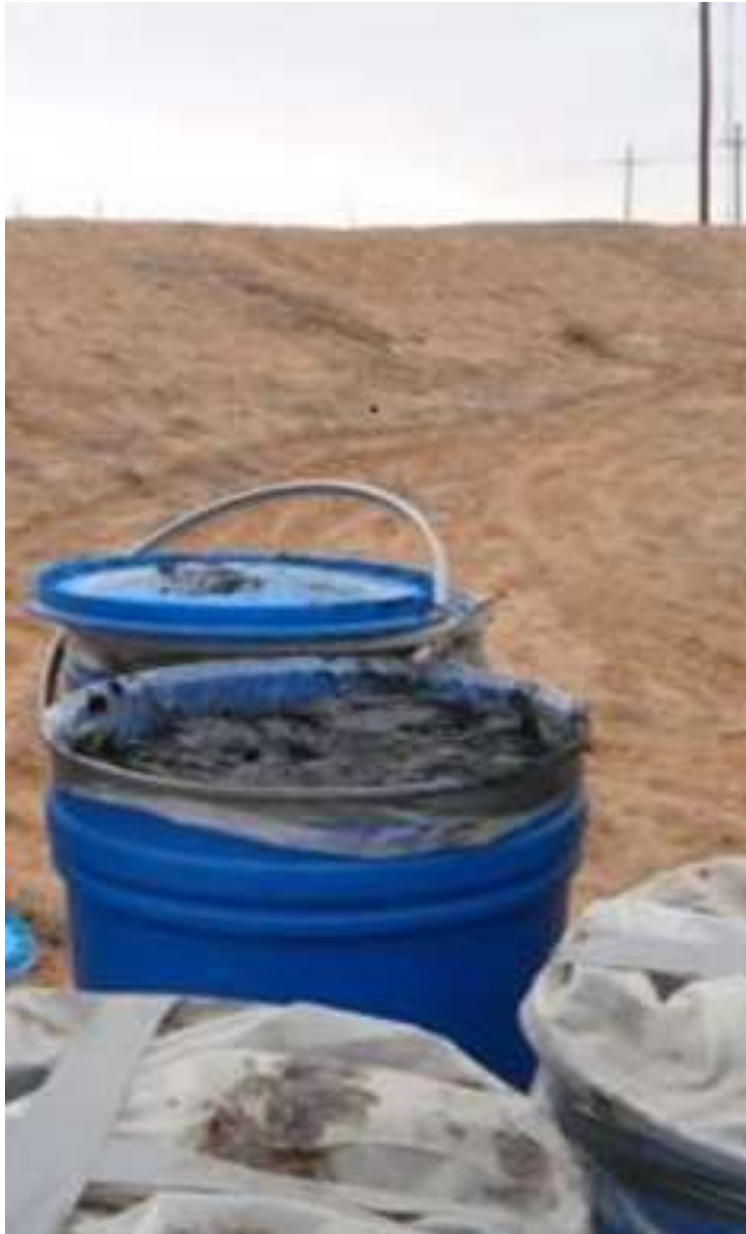
**Photograph 6 of 6
CONVENTIONAL MECHANICAL CLEANING**

Drums of paraffin sludge removed from the tank placed within spill containment dikes. There were seven drums of the paraffin sludge that would be blended with crude and sold for nominal value to offset some of the cleaning costs. Extracted paraffin does have commercial value.
